DORE, Gustave (1832-1883)

*Souvenir des Alpes; Paysage*

Inventory No. 868.1.46

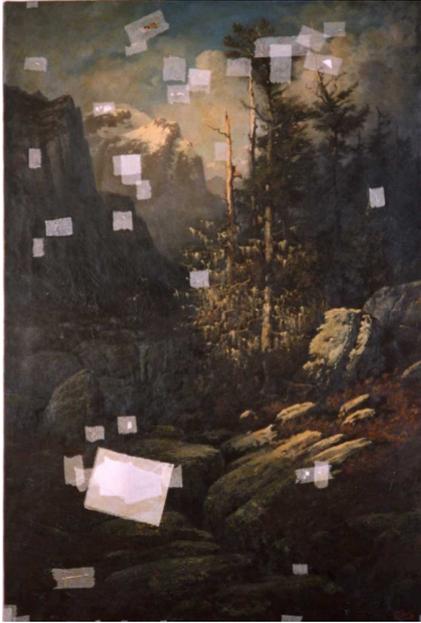
*Fig.1: Full view, before restoration*

Doré's painting was in very poor condition and was difficult to handle without causing further damage. It was deemed necessary, and even vital, to restore the painting.

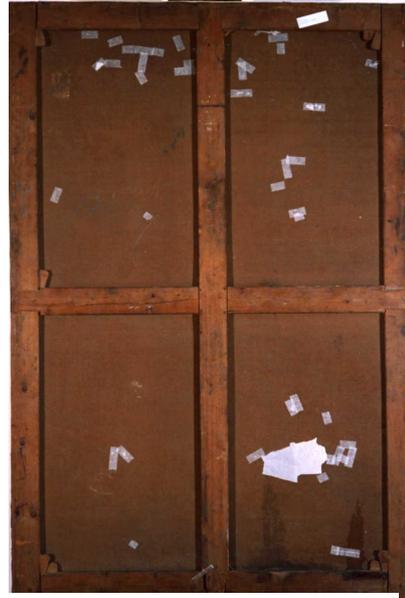
*Fig.2: Full view of the reverse, before restoration*

The support is linen canvas. The canvas is highly oxidized and brittle, and the edges tend to crumble. It is almost impossible to handle the canvas. It has numerous distortions. It is further weakened by the many tears and paint losses, and it has lost much of its original tension. On the reverse, the canvas is deformed by the network of cracks in the paint. (See figures 5 and 6).

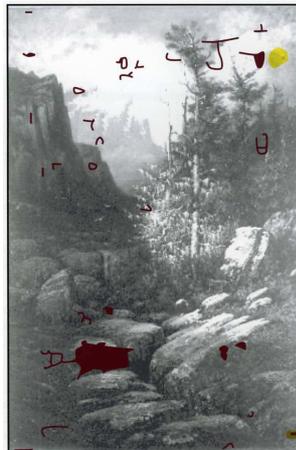
Restoration work has already been performed, with some repaints on the left part of the painting. The paint layer is on a thin layer of white ground that is in good general condition. It is protected by a layer of varnish (not original) that is highly oxidized\* with a yellowish colour that has a negative visual impact.

Fig.5: Tears, holes and repaints

The tears were repaired. They were consolidated by gluing the edges thread by thread, using a synthetic adhesive. The threads used were taken from the edge of the original canvas. They were coated with adhesive and heat was then applied with a heated tip to activate the bond. The paint losses were infilled.

The repaints and infills from previous restoration procedures were removed mechanically using solvent mixtures.

Paint losses were infilled with a fill material applied with a spatula. Once the fill was dry, the edges of the paint losses were cleaned with water. Finally, the infilled areas were worked so as to perfectly match the surrounding areas.

The paint losses were inpainted with powdered pigments mixed with retouch varnish. This was done after a preliminary step consisting of tinting the fill material and varnishing the painting. A reference photograph was used to reconstruct the design of the large area of loss. Although the photo was in black and white, it was nonetheless possible to restore the paint loss without inventing design elements.

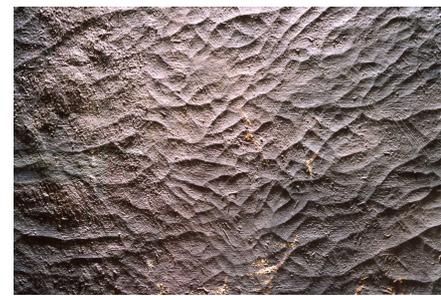
The paint layer in the thickest parts shows significant cupping (Fig. 4). In areas, the paint layer shows poor adhesion on the support (canvas) or even paint losses\* of various sizes. On

Fig. 4, Close-up of the front in raking light. The paint layer is very thick. Extensive cupping can be seen.

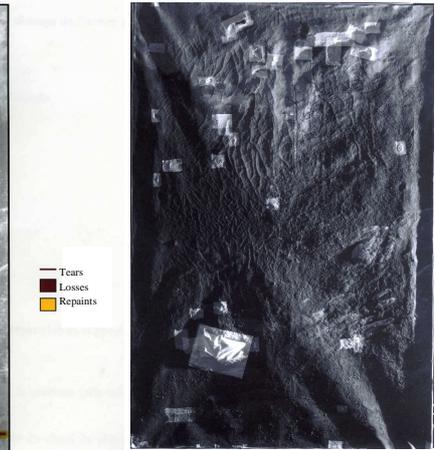
Fig.6: raking light (black and white)

The photos taken under raking light show the problems mentioned above. (See figures 5 and 6).

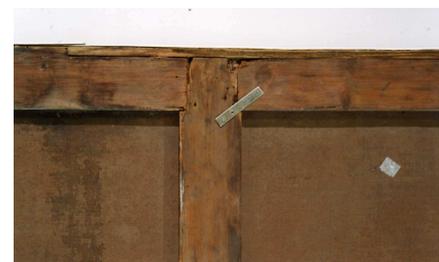
The stretcher\* had been used before and is in very poor condition. It is a stretcher frame with two crossbars\* and it is chamfered\*. It has traces of old nails, a brace (Fig. 7) was added to reinforce one of the members, and there are numerous traces of paint. It has some small holes caused by wood-eating insects that create tunnels for their larvae. The horizontal crossbar is split. The lower crossbar assembly is broken and was reinforced by a metal plate attached with screws. The wedges were pushed in too far, and all of the angles are open by 4 or 5 mm.

Fig.7 : Close-up of the stretcher before replacement, showing a brace added in a previous restoration procedure.

The stretcher was replaced by a new custom-built stretcher. It is a chamfered wood stretcher frame with wedges to regulate the tension.
