DORE, Gustave (1832-1883)

*Souvenir des Alpes; Paysage*

Inventory No. 868.1.46

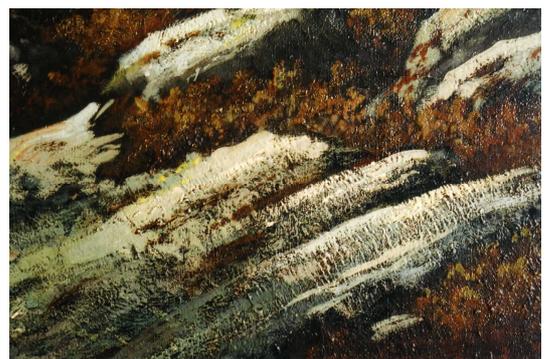
In general, the work is characterised by the use of heavy impasto, with an atmosphere marked by strong contrasts in the light and shadows (chiaroscuro) (See detail Fig. 3).

*Fig.3: Example of the artist's technique. A first olive-green layer was applied and allowed to dry. A thick white tint was then applied and wiped off. (Only the ridges are coloured).*
